**DEPARTMENT OF TRANSPORTATION**

Contract #: 04-0120F4Cty: SF/ALA Rte: 80 PM: 13.2/13.9File #: 69.28**WELDING INSPECTION REPORT****Resident Engineer:** Pursell, Gary**Address:** 333 Burma Road**City:** Oakland, CA 94607**Report No:** WIR-012573**Date Inspected:** 25-Feb-2010**Project Name:** SAS Superstructure**OSM Arrival Time:** 645**Prime Contractor:** American Bridge/Fluor Enterprises, a JV**OSM Departure Time:** 1845**Contractor:** Zhenhua Port Machinery Company, Ltd (ZPMC), Changxing Island **Location:** Shanghai, China**CWI Name:** Xu Le Feng**CWI Present:** Yes No**Inspected CWI report:** Yes No N/A**Rod Oven in Use:** Yes No N/A**Electrode to specification:** Yes No N/A**Weld Procedures Followed:** Yes No N/A**Qualified Welders:** Yes No N/A**Verified Joint Fit-up:** Yes No N/A**Approved Drawings:** Yes No N/A**Approved WPS:** Yes No N/A**Delayed / Cancelled:** Yes No N/A**Bridge No:** 34-0006**Component:** Tower Components**Summary of Items Observed:**

Tower Trial Assembly

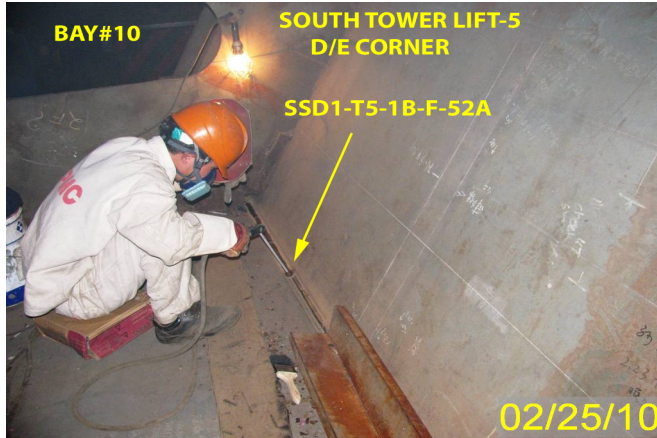
Weld joint # 52A located on South Tower Lift-5 D/E corner SSD1 – TL5 – 1B – F. Welder is identified as 050289. ZPMC Quality Control (QC) Inspector is identified as Wang Hao. The welding variables recorded by QC appeared to comply with the WPS – B – T – 3211 – Tc – U4b – 1.  
(See attached photo)

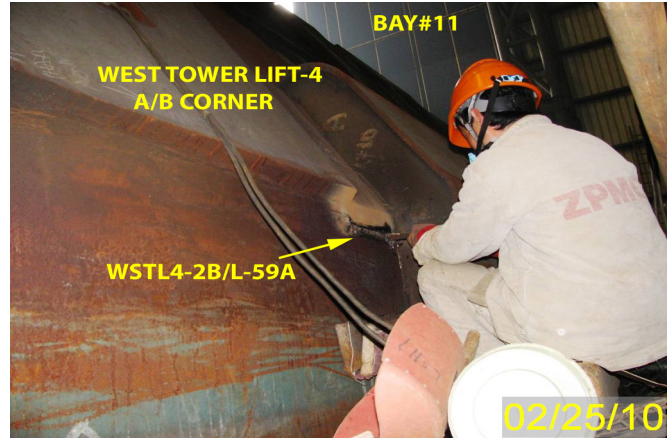
Repair welding of a weld joint # 59A according to the weld repair report #T-WR-3071 located on West Tower Lift-4 A/B corner NSTL4-3B/L. Welder is identified as 053916. ZPMC Quality Control (QC) Inspector is identified as Shao Hai Lang. The welding variables recorded by QC appeared to comply with the WPS – 345 – SMAW – 2G (2F) – Repair.

(See attached photo)
